Frequency Screening of First Stage Turbine Blades in the T56-A-7B Engine

Andrew Becker and Paul Marsden

DSTO-TN-0223

Historically it has been difficult to obtain accurate and repeatable frequency data for the first bending mode of turbine blades. This report summarises the technique used by AMRL to screen first stage T56-A-7B turbine blades for the Royal Australian Air Force as part of an investigation into the failure of these blades in service.

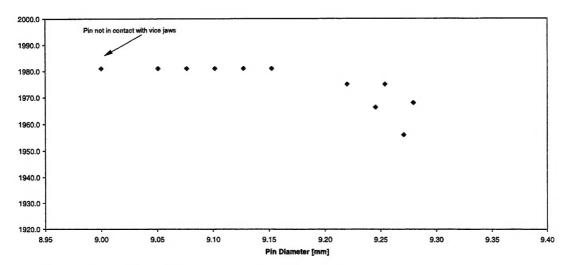
Figure 2. Effect of load sharing pin on blade 1B frequency

This approach was trialed during the initial testing of new blades for the RAAF. The load-sharing pin, however, was found to be unnecessary in the AMRL machine vice as the blade frequency appeared to be maximised before the pin took effect. Figure 2

illustrates how the test blade frequency altered with changing diameter of load sharing pin for the AMRL machine vice.

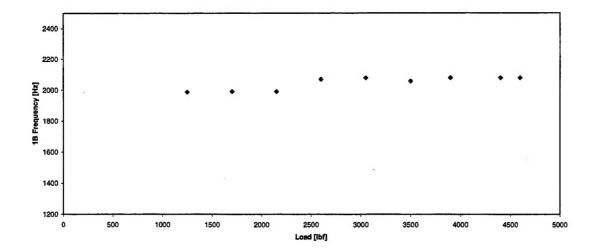
Figure 3. 1B Frequency sensitivity to clamping force

Additionally, a sensitivity check was conducted to see how the 1B frequency was effected by clamping force (Figure 3). This check revealed that there was only minor variation in frequency as the clamping load was increased. It should be noted that at clamping loads below those shown, the 1B frequency was no longer clearly distinguishable on the Fast Fourier Transform (FFT) analyser.

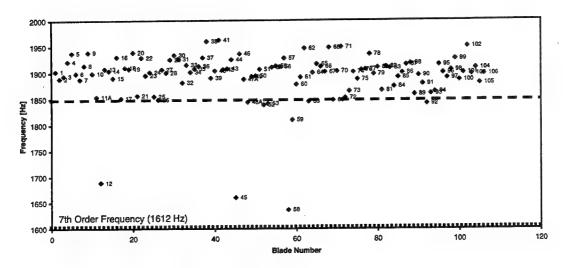
Figure 4. Initial AMRL 1B frequency results

Before the frequency screening technique could be implemented at Qantas, the data obtained at AMRL needed to be correlated with that obtained by RRA. RRA stated that all new blades should have a 1B natural frequency above 1850 Hz when tested in the laboratory. Initial testing by AMRL appeared to reveal several blades that exhibited frequencies significantly lower than the minimum claimed by RRA (Figure 4). More importantly, these blades appeared to have frequencies very close to the seventh

engine order. The entire set of 109 blades were sent to RRA for correlation which revealed a significant discrepancy between the AMRL frequency data and that obtained by RRA. Specifically, blades 12, 45, 58 and 59 appeared to have low frequencies when tested by AMRL and satisfactory frequencies when tested by RRA. Also, there appeared to be a 200 Hz discrepancy between the mean for each data set. It was thought that there may have been a problem with the clamping arrangement so a new coupon was made at AMRL from blade material.

RRA had suggested that the vice initially used by AMRL was too light and may have effected the frequencies recorded [7]. A larger and heavier machine vice was acquired and this combined with the new coupon appeared to account for the majority of the 200 Hz difference. Unfortunately this vice could not be correlated using the initial 109 blades as they were detained for an extended period in the United States of America under a trade regulation.

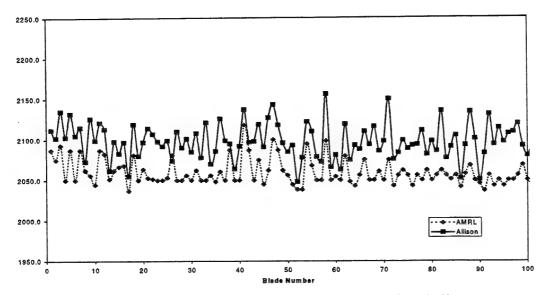
Figure 5. Correlation between AMRL and RRA 1B frequency data (Batch A)

By the time the 109 blades were released and returned to AMRL, a new hydraulic vice (described in Section 3) had been constructed and was in use. Figure 5 shows the correlation between the RRA frequency data for the 109 correlation blades, and the AMRL hydraulic vice frequency data. As both data sets followed very similar trends, the correlation was considered acceptable despite the apparent 50 Hz shift.

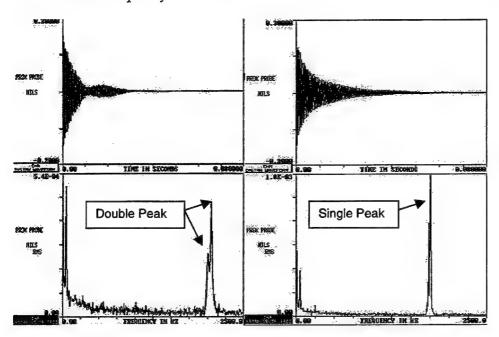
Figure 9. Double frequency peak (left) and single frequency peak (right)

Whilst testing the large number of new blades (approximately 2000 blades), it was noted that some blades displayed two peaks less than 50 Hz apart and of similar amplitudes on the frequency display of the FFT analyser. Figure 9 shows both a double frequency peak and a single frequency peak together with the respective time trace. The double peak phenomenon was unable to be explained, however the beat frequency evident in the time domain trace is most likely related. Occasionally a double peak appeared and a predominant peak could not be deciphered (both peaks were approximately the same amplitude); when this was observed, the lower peak was taken as the 1B frequency.
